DEPARTMENT OF TRANSPORTATION

Quality Assurance and Source Inspection

Contract #: 04-0120F4Cty: SF/ALA Rte: 80 PM: 13.2/13.9File #: 69.28**WELDING INSPECTION REPORT****Resident Engineer:**Pursell, Gary**Address:** 333 Burma Road**City:** Oakland, CA 94607**Report No:** WIR-002659**Date Inspected:** 23-May-2008**Project Name:** SAS Superstructure**OSM Arrival Time:** 700**Prime Contractor:** American Bridge/Fluor Enterprises, a JV**OSM Departure Time:** 1700**Contractor:** Zhenhua Port Machinery Company, Ltd (ZPMC), Changxing Island **Location:** Shanghai, China**CWI Name:** Sun Wei**CWI Present:** Yes No**Inspected CWI report:** Yes No N/A**Rod Oven in Use:** Yes No N/A**Electrode to specification:** Yes No N/A**Weld Procedures Followed:** Yes No N/A**Qualified Welders:** Yes No N/A**Verified Joint Fit-up:** Yes No N/A**Approved Drawings:** Yes No N/A**Approved WPS:** Yes No N/A**Delayed / Cancelled:** Yes No N/A**Bridge No:** 34-0006**Component:** OBG**Summary of Items Observed:**

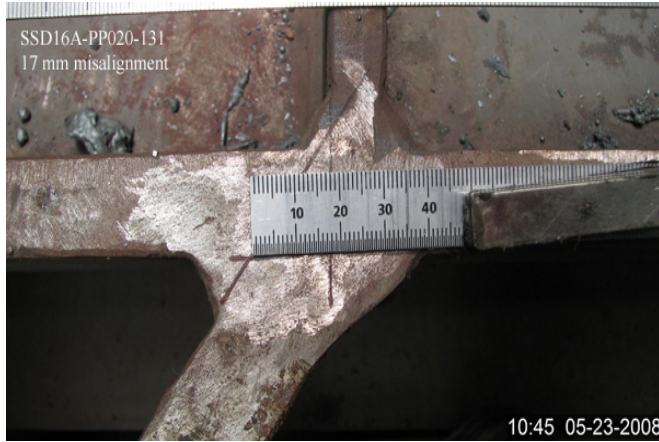
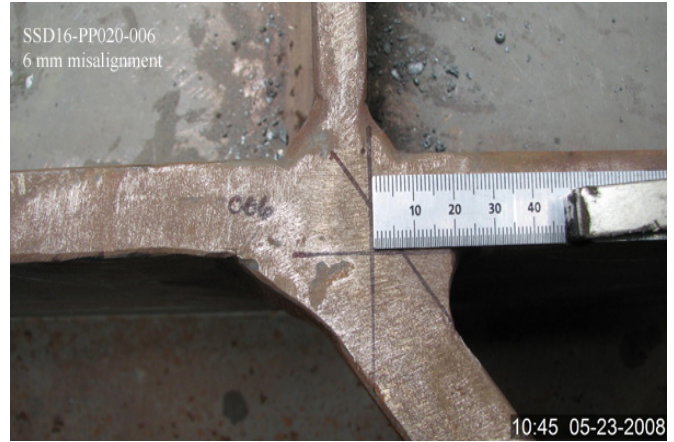
The Quality Assurance Inspector performed a survey of the Chevron Bracing Plates to Floor Beam Bottom Flanges misalignment between the Chevron Bracing and the Vertical Stiffener. The Quality Assurance Inspector measured the misalignment as follows:

Below are two digital photographs illustrating how the misalignment was measured. The Quality Assurance Inspector was informed the maximum allowable misalignment was 1.4 millimeters. The Quality Assurance Inspector generated an incident report pertaining to the discrepancy.
